VESSEL SURVEYED "Ashanti"  
DATES OF SURVEY: August 24 2016  
REGISTRATION:  
H.I.N. AU-TWAO35736 D09

## **Purpose:**

To provide information to the client concerning the condition of the vessel's for continued insurance purpose.

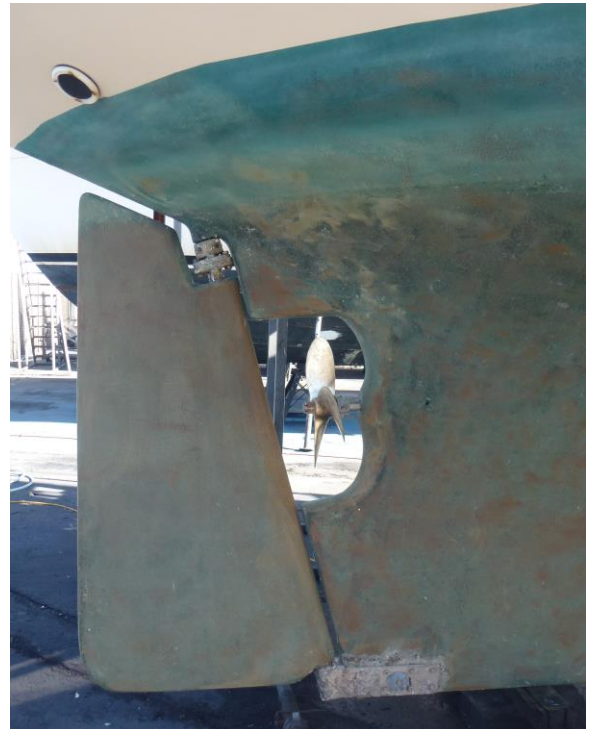
Both shaft and the brass manganese propeller were free of damage and observed to be in good order. I did not find any excessive play or movement, upon testing the shaft by way of force.

The propeller was observed to be correctly secured to the shaft on the day of inspection.

The photo on page four allows the observer to view both the condition of the gear, as well as to observe the work that has and is being completed as part of routine maintenance.

A new anode was to be fitted to the vessel shaft.

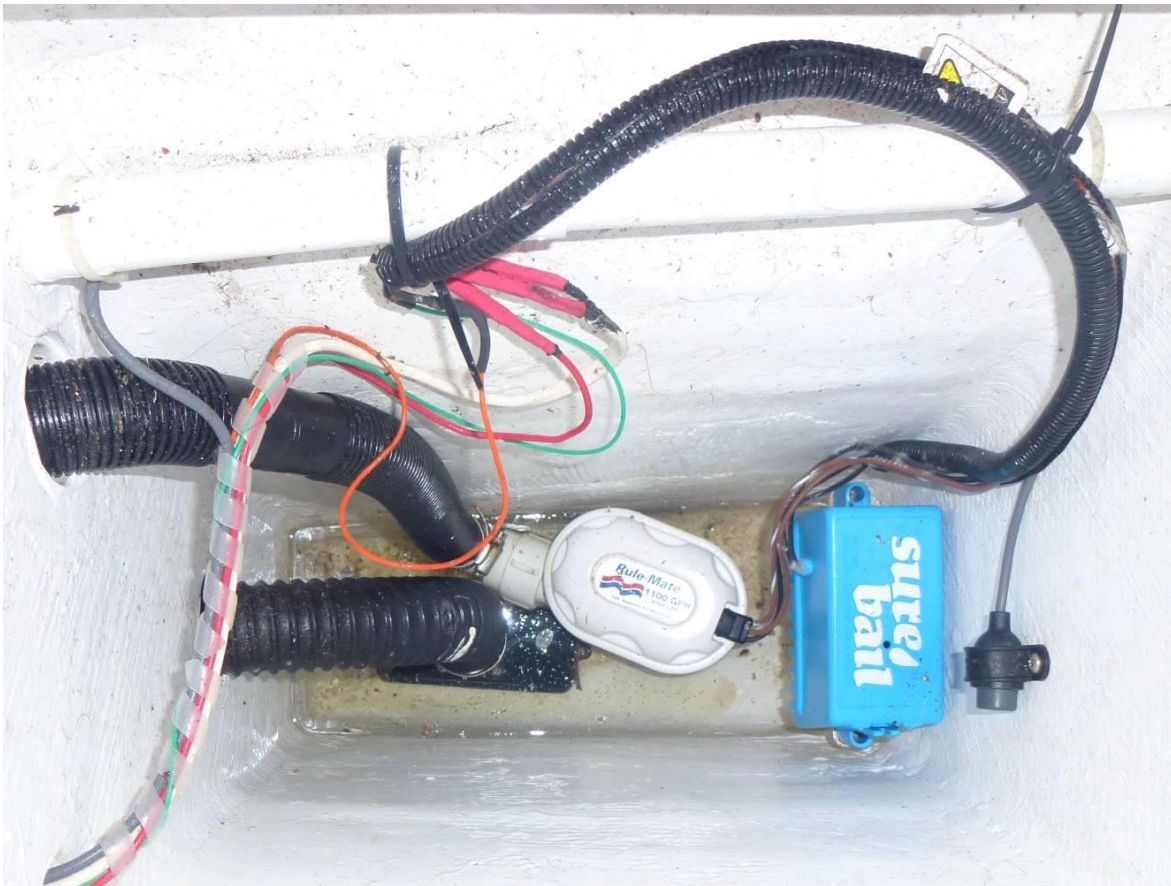
The bilge areas both within the main cabin and forward of the head were all observed to be well finished and the internal sheathing to preserve the timbers in good order, nil delaminating observed. The below photo provides the viewer with the combination of automatic and manual bilge pump arrangement aft section only. The sensor for the alarm panel can also be seen as well as the sheathing of the timber work.

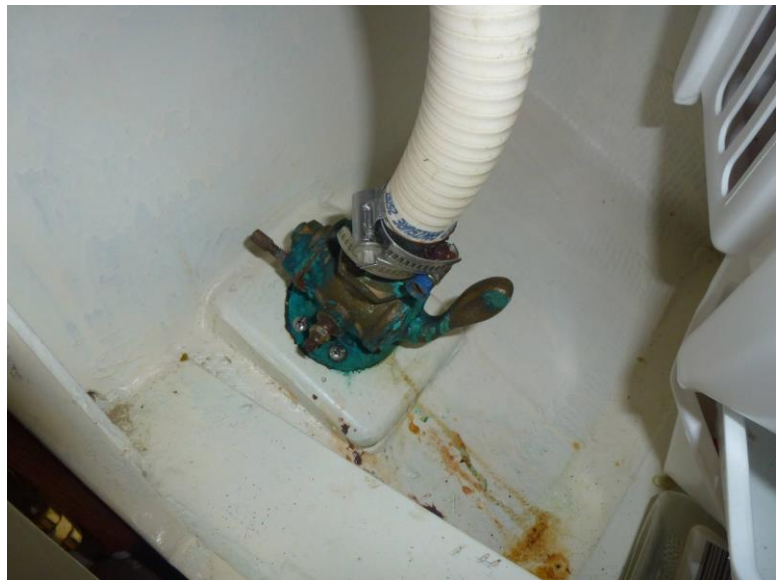
The plumbing was observed to be in fair condition with several seacocks in need of cleaning and possible errors with the type of metals used for fastening of the hoses, with some fasteners in need of replacement. I did not observe electrolysis of the timber or backing plate from incorrect bonding.

NOTE: Dissimilar metals can be used in marine settings, however any degree of moisture and or allowing them to come in connection with each other will cause a degree of corrosion and if left will cause the part in concern to fail. Refer to the below photo.

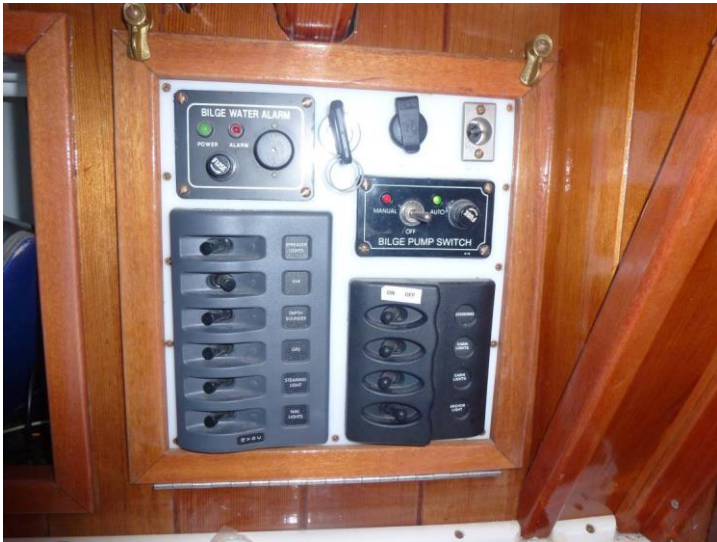
Switchboard, bilge and high water alarm.

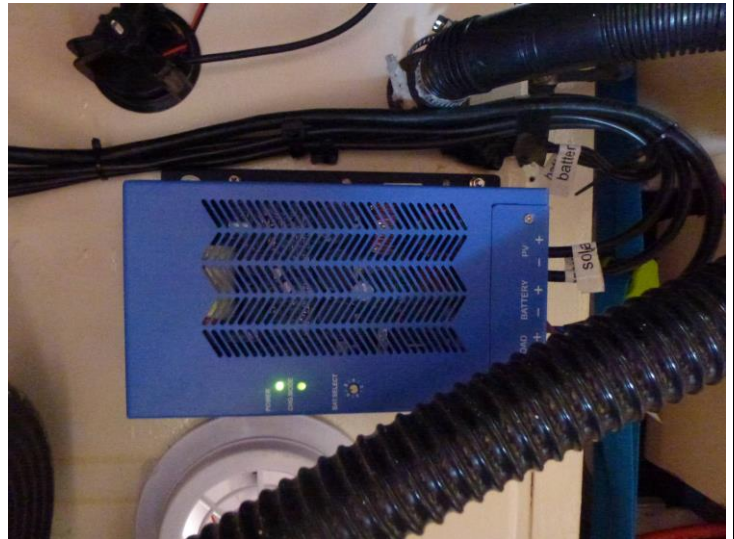
Solar inverter powered up and wiring clearly labelled.

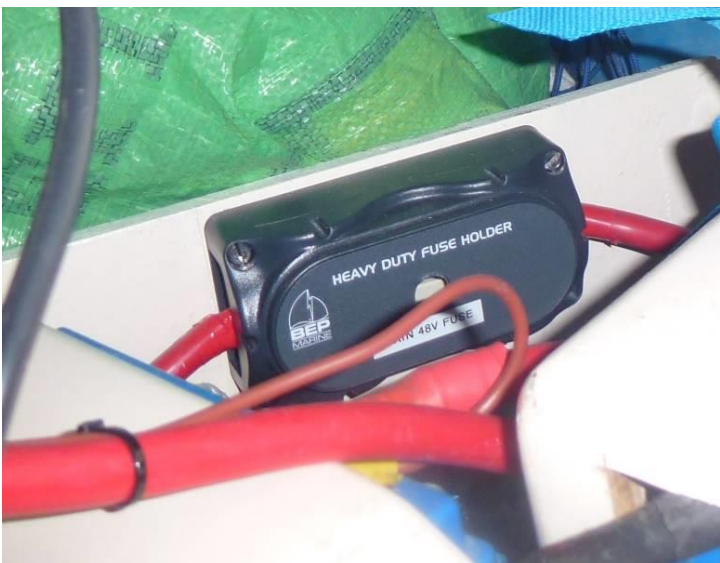
Heavy duty fuse holder and dual 48V fuse. As per photo nil stray wires.
